Terahertz Imaging and Backscatter Radiography Probability of Detection Study for Space Shuttle Foam Inspections

Warren Ussery
Lockheed Martin Space Systems Company
504-257-1934

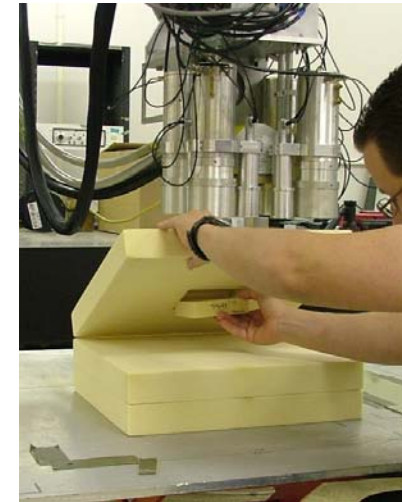
POD test article

- Test article consisted of flat blocks with inserted semi-natural defects
- This design allowed POD calculation for different defect depths and foam thicknesses
- Sample population of 400 composed of 100 defects and 300 blanks
- A POD sample consisted of a BSX and THZ inspection of one coupon
- Three interpreters analyzed the 400 samples for a total of 1200 discrete results

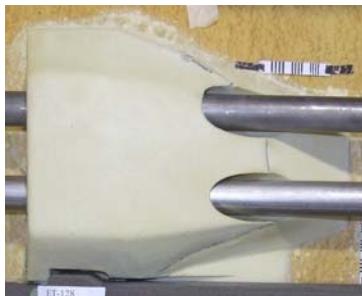
ET Ice Frost Ramp

Ice frost ramps are one application that currently undergoes NDE on each External Tank.

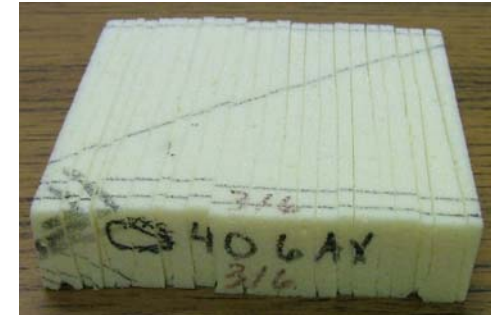
Coupon with defects after final dissection
